TECHNOPARK
VTP KRALUPY

CORROSION RESISTANCE TESTING OF CLIMBING HANGERS ACCORDING TO EN 795 STANDARD REQUIREMENTS

Report No.: **M528**

Customer: **Lappas S.A.**
5th Km nat.rd. Ioannina-Athens
45500 IOANNINA
GREECE

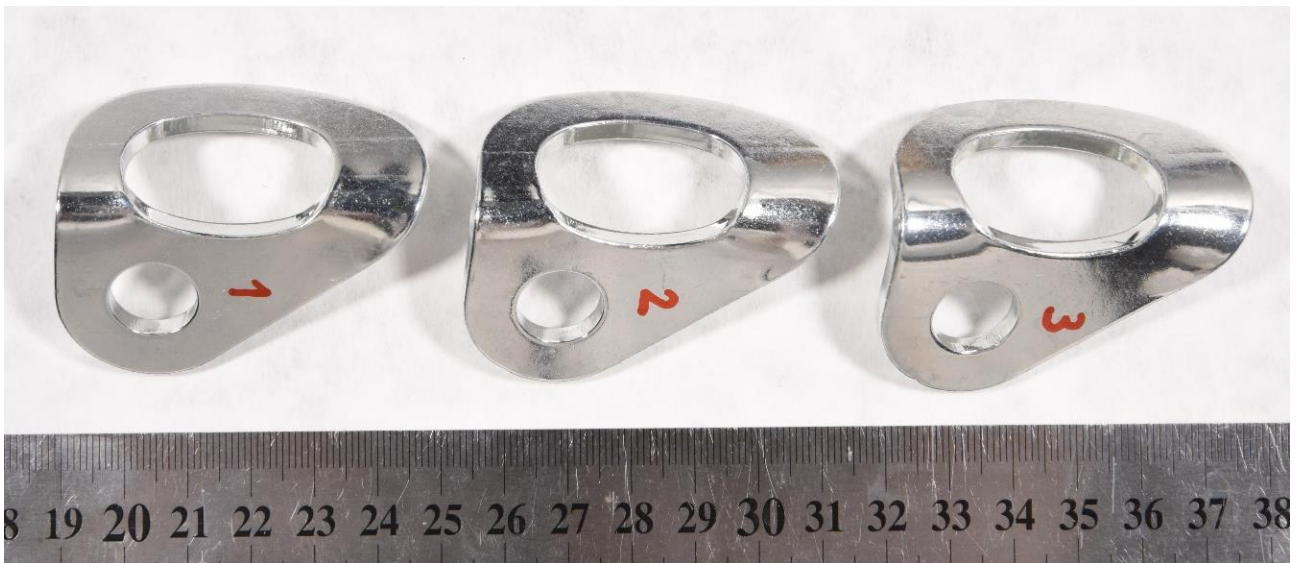
Three pieces of Lappas hangers made of zinc coated steel were cleaned with ethanol and marked with numbers 1–3. The hangers are shown in **Figure 1** and **Figure 2**.

Figure 1. Lappas hangers before testing, back side

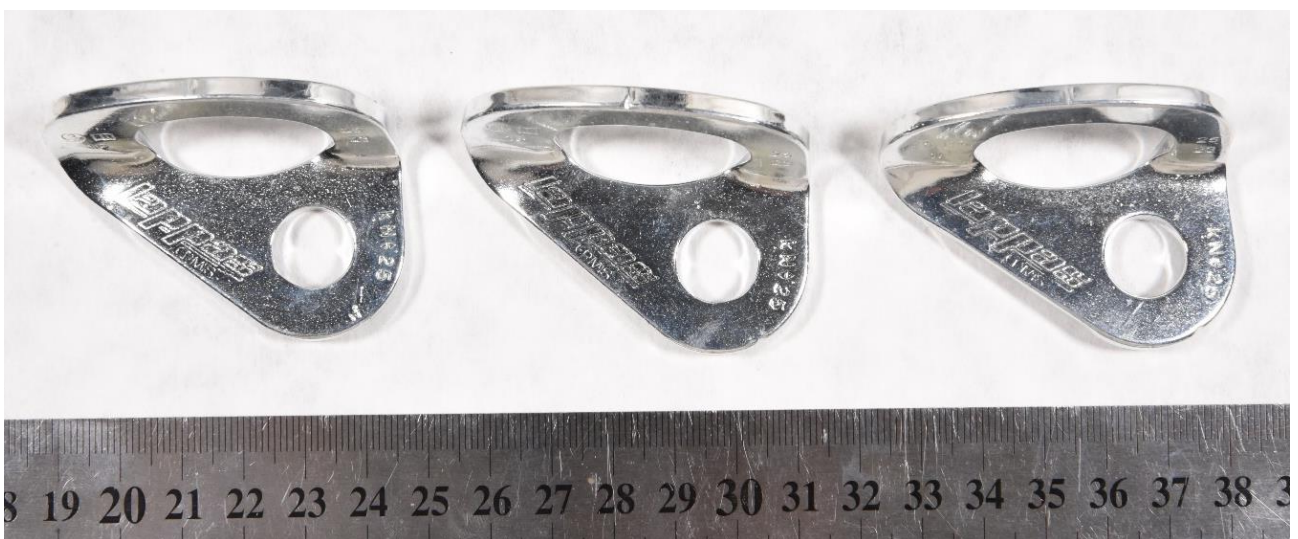
Figure 2. Lappas hangers before testing, front side (1 to 3 from left to right)

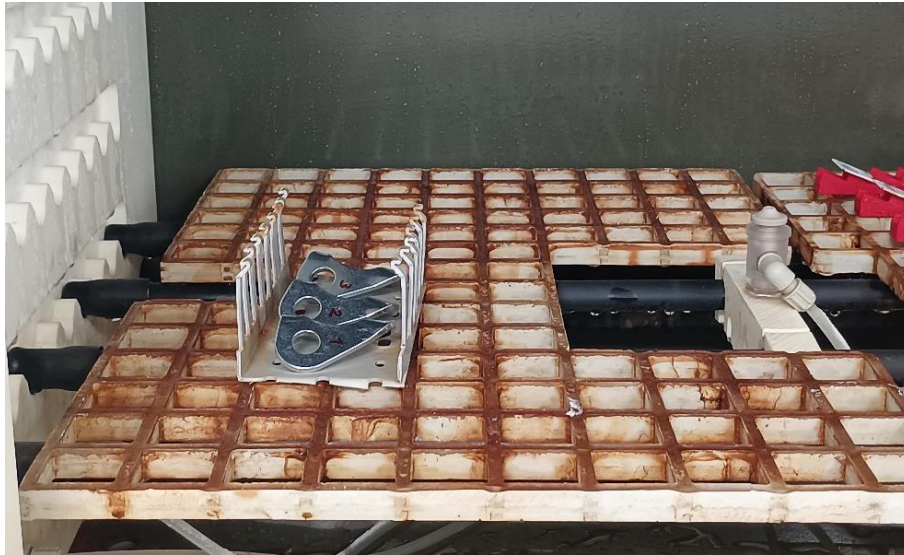
Placement of the samples in the NSST chamber VLM CCT 400-FL VDA-I is seen in **Figure 3**.

Figure 3. Specimens on a holder in the NSST chamber

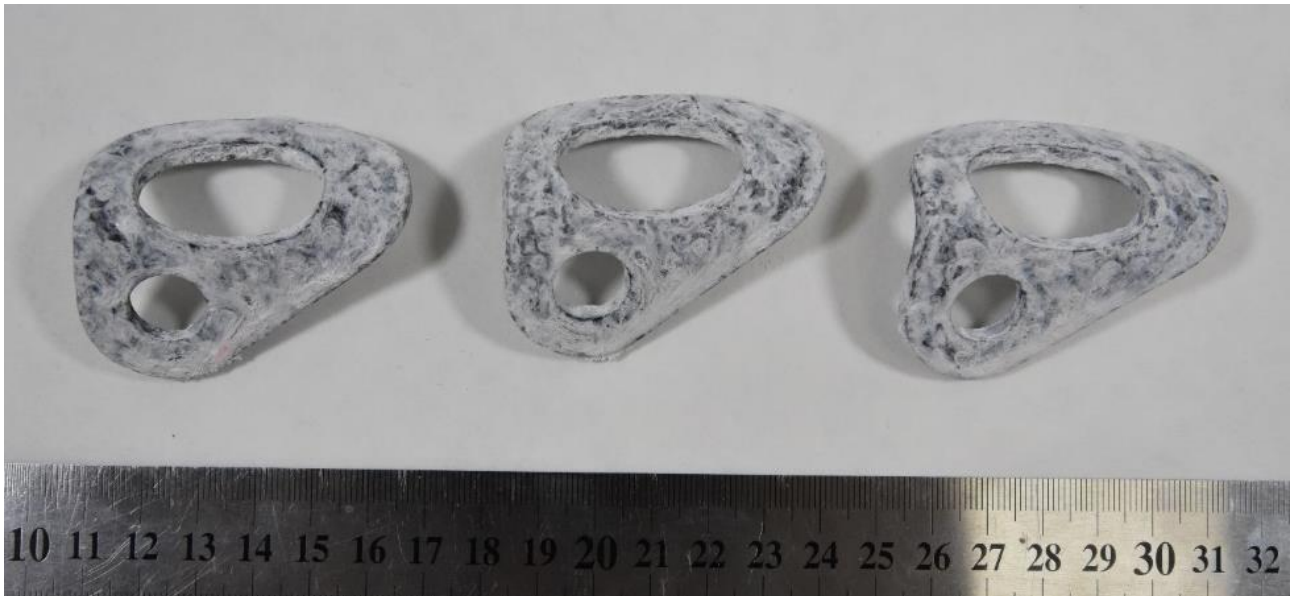
Photographs of all specimens are shown in **Figure 4** and **Figure 5**. Only white corrosion products of the zinc coating was formed on all specimens. They were completely free of red corrosion products from steel. The base material was thus not damaged.

Figure 4. Hangers after the test, front side (1 to 3 from left to right)

The tested anchors meet the requirements of EN 795 for the corrosion resistance of anchor devices. There was no corrosion of the base material.

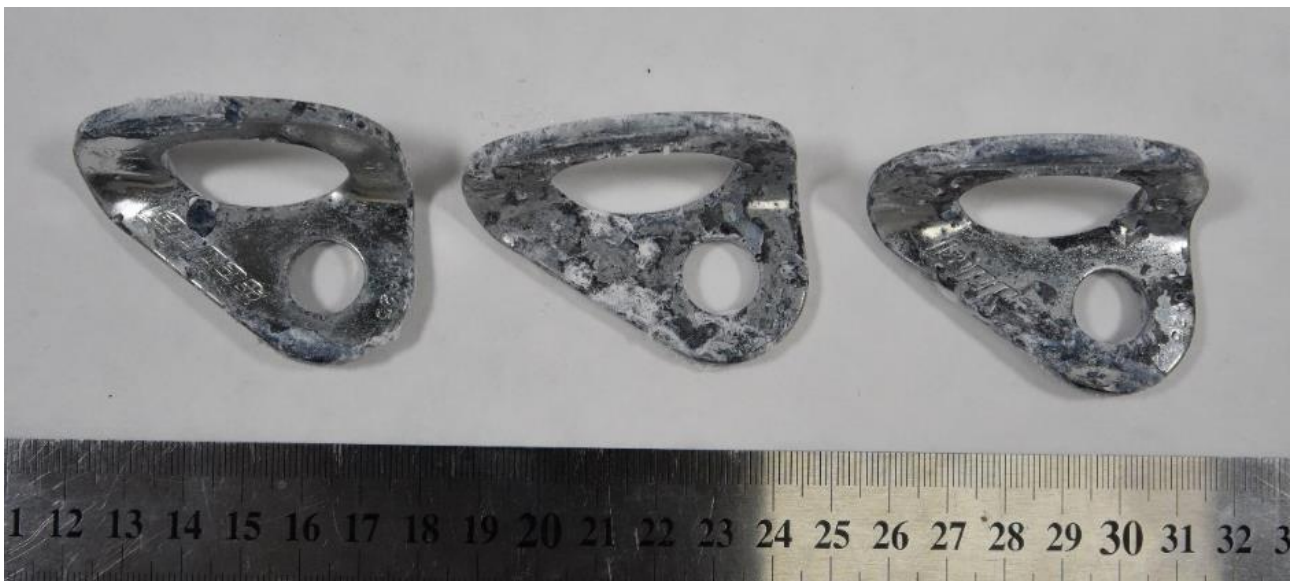
Figure 5. Hangers after the test, back side (1 to 3 from left to right)

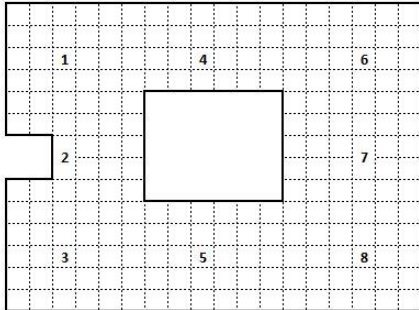
Collection vessel	Deposition rate	Deviation	Position of the collection vessel in the chamber
1	34

2	32		
3	24		
4	28		
5	31		
6	31		
7	30		
8	25
